Report to:	Mount Buller and Mount Stirling Alpine Resort Management Board
Prepared by:	Michael Goddard, Jane Kenny
Biosis project no.:	31189
File name:	31189.Mt.Buller.WSP.HEMAMP.Impact.Yr1.DFT02. 20201001.docx
Citation:	Biosis 2020. Mount Buller Water Storage Project – Hydrological and Ecological Monitoring and Adaptive Management Program: Impact Year 1 Monitoring. Report for Mount Buller and Mount Stirling Alpine Resort Management Board. Authors: Goddard M and Kenny J, Biosis Pty Ltd, Melbourne. Project no. 31189.
Cover photo:	Looking west over Alpine Bogs at Mount Buller

In October 2019, the Mount Buller and Mount Stirling Alpine Resort Management Board (the RMB) started construction of a 100-megalitre off-stream water storage and ancillary infrastructure (the project) on Mount Buller within a 10.347-hectare Project Construction Footprint (PCF) between the summit and the village. As part of the project, the RMB is implementing a Hydrological and Ecological Monitoring and Adaptive Management Program (HEMAMP), with an objective of maintaining the extent and condition of Alpine Bogs that are downslope of the water storage.

In accordance with approvals for the project (EPBC Act Ap

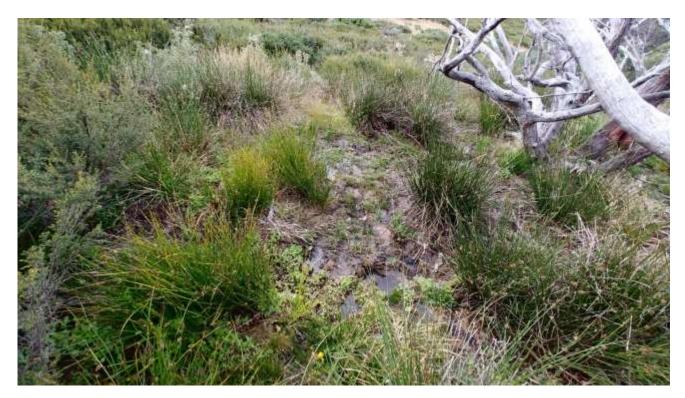
- Herbivory and damage from deer: The damage caused by Sambar Deer Cervus unicolor
 wallowing, trampling and browsing is readily apparent in the northern half of Bog 6 (Photo 3).
 This may have contributed to the state of flux observed in the northern half of Bog 6 since BY1.

Photo 3 Damage caused by Sambar Deer at the northern half of Bog 6.

- 9. Weed control should continue at all Alpine Bogs, prioritising areas of sedimentation, deer damage and the localised weed infestations within and on the margins of the Alpine Bogs (particularly at Bogs 1, 2, 4.1/5/7, 6, 11.1, 11.2 and S1). The following weed species should be targeted:

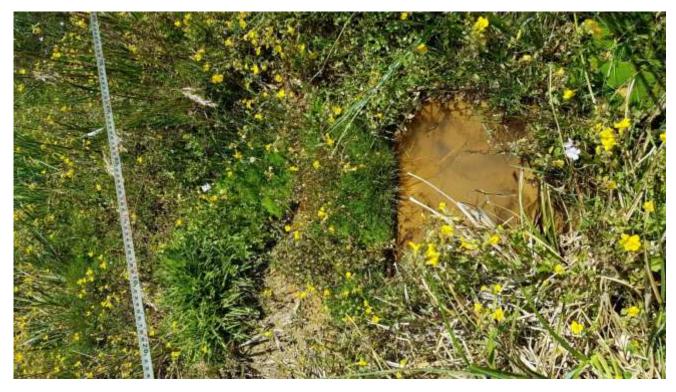
Already, some areas that are buried in 10-20 centimetres of sediment have been colonised by weeds, resulting in loss of Alpine Bog extent (e.g. along the northern boundary of Bog 4.2 and south-west and central areas of Bog 6). Sedimentation has assisted in the proliferation stoloniferous and rhizomatous weed species, such as Brown-top Bent *Agrostis capillaris* and Musk Monkey-flower *Erythranthe moschata*. These species are able to actively and rapidly grow through the sediment. Other weed species, such as Yorkshire Fog *Holcus lanatus*, Creeping Fescue *Festuca rubra* and Soft Rush *Juncus effusus*, may or may not be stoloniferous or rhizomatous, but are tall enough to persist through the sediment layer, unlike many shorter bog-dependent flora species, such as Peat Moss and Carpet Sedge.

Photo 4 Sedimentation and weed proliferation along Transect 6C.
